Scissors lift Repair and reconstruction

Do you need components that are very expensive as original spare parts or are certain spare parts no longer manufactured? We supply you with precisely fitting reconstructions.

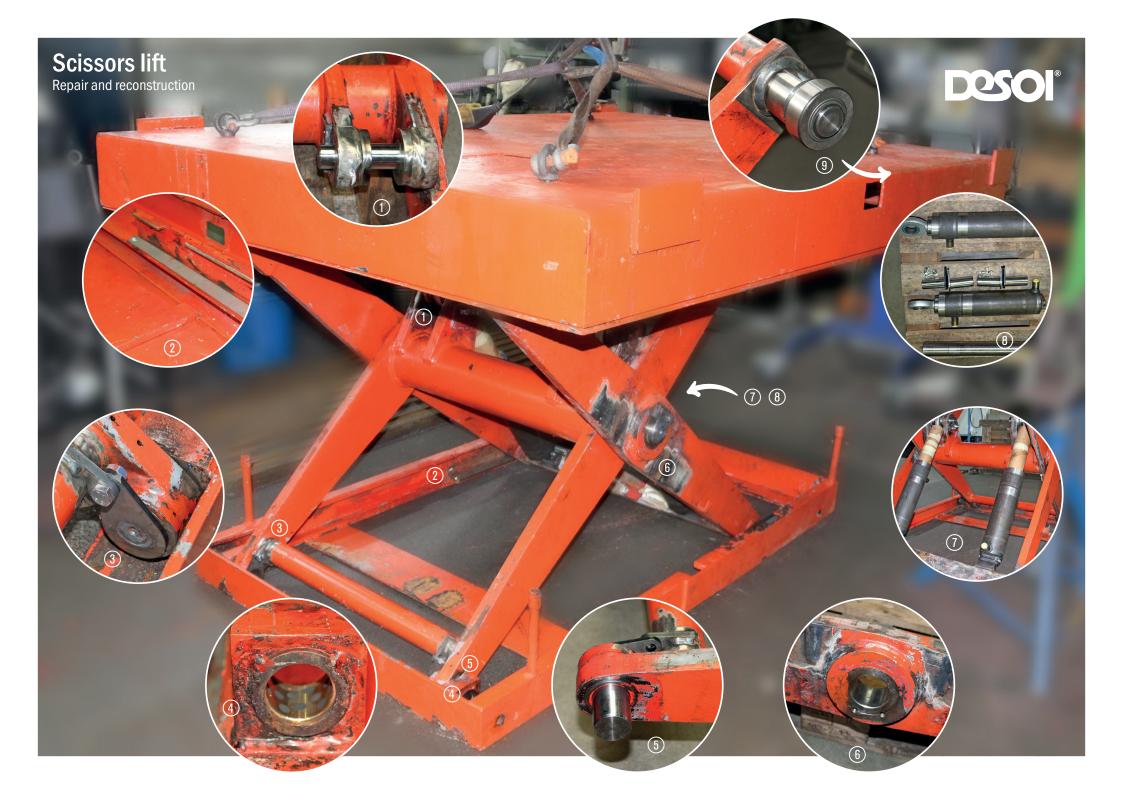
Cylinder suspension renewed on both sides at the top of the inner shear

② Lower running rail inside the platform, running rail with wear strip on the running surface

③ Lower bearing with additional anti-rotation protection of the bolt

④ Lower bearing modified from DU plain bearing bush to solid bronze bush with solid lubricant

5 Lower bearing with additional anti-rotation protection of the bolt

③ Renewed bearing for the middle shear bolt

⑦ View into the inside of the scissor lift (cylinder side) after the overhaul

I New hydraulic cylinder set with centre shear bolt and bearing bolt

(9) Upper roller with new and reinforced bearing journal
